2003-2010 Sanitary Sewer Overflow Evaluation Report

Including Building Backups and Trend Analysis

Submitted to EPA on April 29, 2011

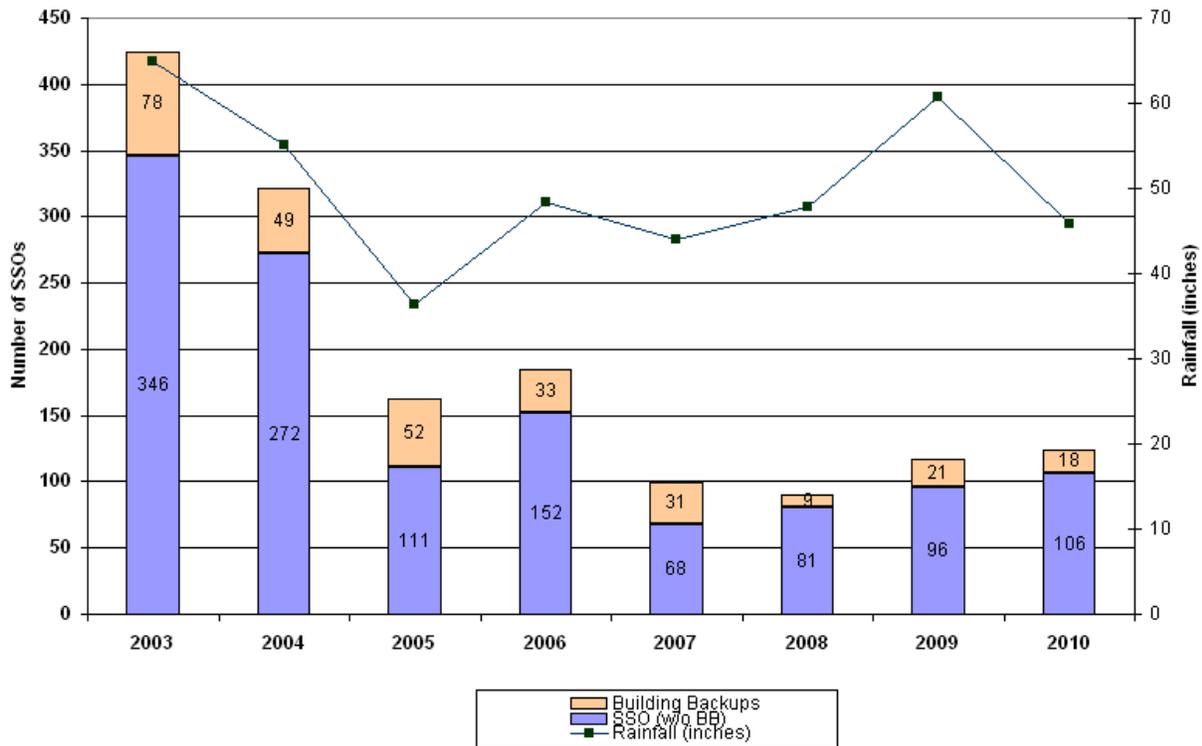
**Annual Sanitary Sewer Overflow Totals
(including Building Backups)**

Figure 1 illustrates the overall significant decline in sanitary sewer overflows, including building backups over the last eight years. The slight increase in 2006 relative to the previous year can be attributed to a three-day period of rain in September. During this event, rain gauges across our service territory recorded between 4.39 and 5.88 inches of rain. This event, which exceeded a two-year 24-hour storm return period, resulted in 33 rainfall-related SSOs. Those 33 events accounted for 49 percent of the wet-weather SSOS that occurred during 2006.

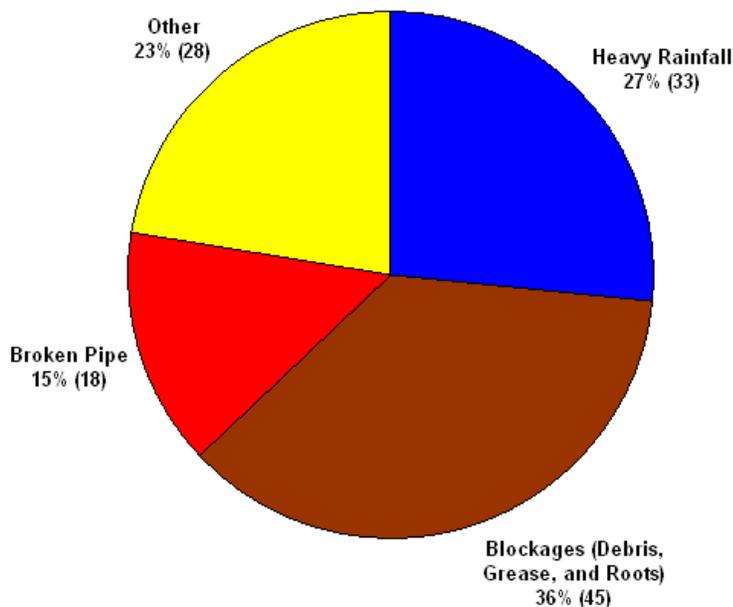
Figure 2
KUB Causes of SSOs in 2010
(Including Building Backups)

Figure 2 presents a comparison of SSOs by causes. In this graph, the SSOs were grouped into four categories:

- Heavy Rainfall
- Blockages (Debris, Grease, and/or Roots)
- Broken Pipe
- Other (Construction Failures, Flushing Operations, Grinder Pump Failure, Vandalism, WWTP, and Pump Stations).

There were 91 dry-weather SSOs, including building backups, in 2010. Although blockage related SSOs decreased from 53 in 2009 to 45 in 2010, there were 11 more dry-weather occurrences involving broken pipe in 2010. Overall, the percentage of dry-weather SSOs stayed at approximately 74 percent relative to 2009.

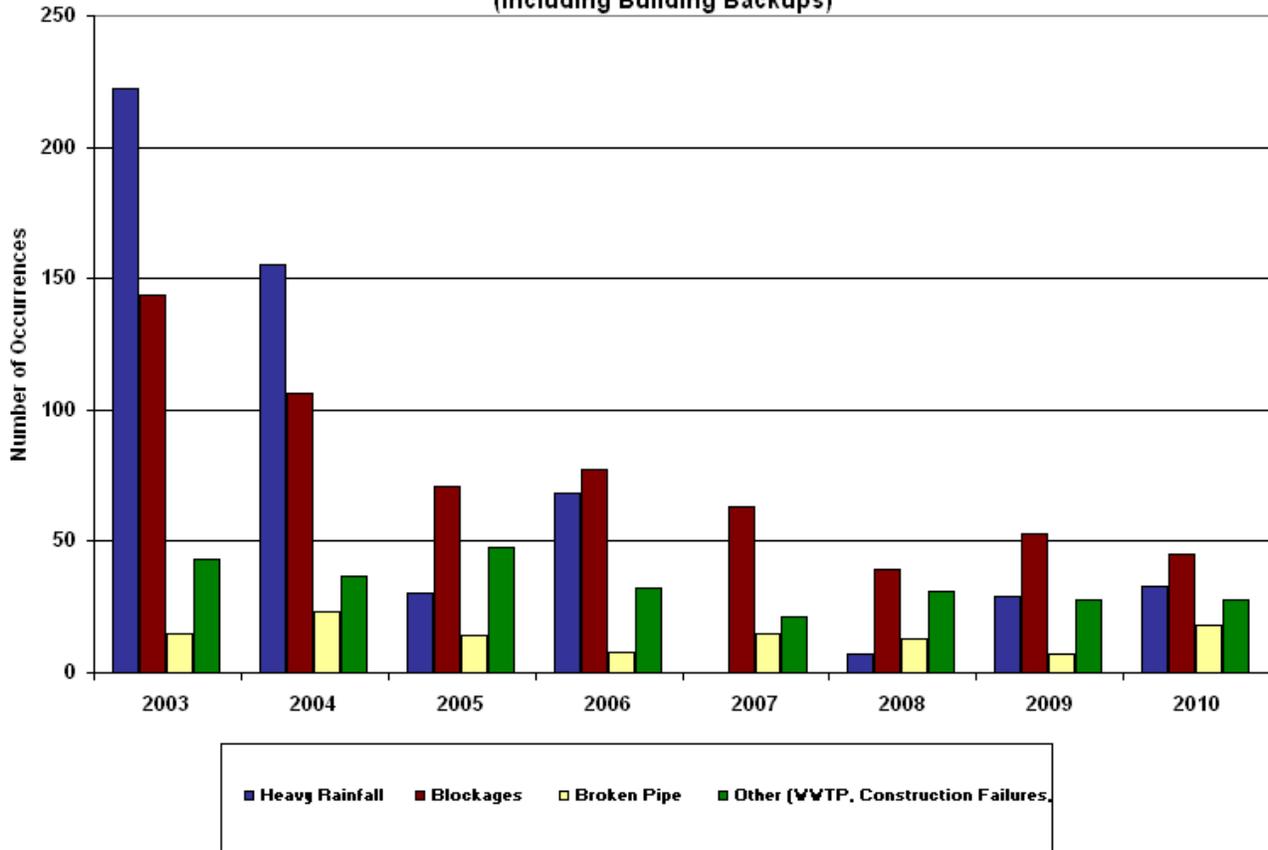
Figure 3
Sanitary Sewer Overflow Causes
(Including Building Backups)

The SSOs for 2010 are also grouped into one of four general categories by each year in Figure 3 for analysis. System cleaning, root removal, tank construction and replacement/rehabilitation projects continue to decrease the number of events, duration, and volume.

As illustrated in Figure 3, blockage-related events have been the major cause of SSOs in recent years, but they have declined by almost 70 percent since 2003. Blockage-related events decreased from 53 in 2009 to 45 in 2010. Blockage related SSOs can be influenced by rainfall, especially with increased collection system flows following an extended dry period. This is seen in the slight increases in 2006 and 2009 relative to the previous years. There were at least 10 blockage-related events in 2009 that occurred in conjunction with higher flows and seven in 2010. Grease and debris tend to accumulate in the collection system during dry periods with lower than typical flows. Higher flows following rainfall events can then move these materials through the system and cause blockage-related overflows at another location.

Figure 3 indicates rain was the largest contributor to SSOs in 2003 and 2004. Heavy rainfall in February 2003, which resulted in flooded roads, homes, and businesses, caused rainfall derived inflow and infiltration (RD I/I) to exceed system capacity and led to 115 SSOs. These SSOs accounted for over 50 percent of occurrences reported for that year. A similar situation occurred again in 2006 due to a three-day period of rain from September 22-24. During this event, rain gauges across our service territory recorded between 4.39 and 5.88 inches of rain, with one-day (24 hour) totals above 3.5 inches. PACE 10 improvement projects reduced the impact during this rainfall event. This period produced 33 rainfall-related overflows, which represented 22 percent of the SSOs that occurred in 2006, but significantly fewer overflows than experienced in February 2003.

Figure 3 shows SSOs due to broken pipe increased by 47 percent from 2006 to 2007, which was likely due primarily to drought conditions. Dry ground can shift abruptly and weaken pipe joints. There was a 13 percent decrease from 2007 to 2008 and a 69 percent decrease from 2008 to 2009. A total of 18 SSOs resulted from broken pipes within our system in 2010. This includes an increase of 11 relative to 2009. KUB continues to proceed with a significant amount of system rehabilitation and main line replacement to keep occurrences related to broken pipes low. Over 160 miles of pipe have been rehabilitated since the beginning of the PACE 10 program.

As Figure 3 indicates 'Other' causes decreased after 2005 on average about 50 percent, but remained somewhat flat in recent years. KUB continues to look closely at the specific causes within this category to eliminate SSOs, whenever possible. This past year 13 SSOs were caused by grinder pump failures. Ten of these events occurred within the same subdivision. As a result, the valves were replaced on all the pumps within this area to prevent additional occurrences. The maintenance schedule for grinder pumps was also reviewed and has been improved. All 140 KUB-owned grinder pumps in our service area will be assessed in 2011 and put on a more aggressive maintenance schedule.

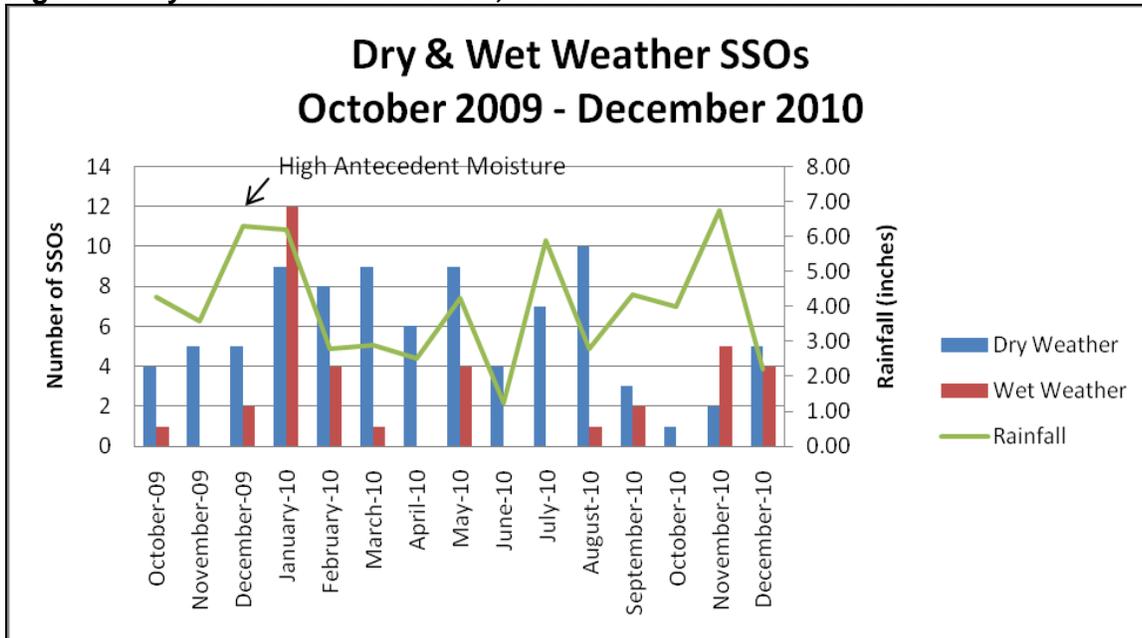
Figure 4. Dry- & Wet-Weather SSOs, October 2009 – December 2010

This wetter period produced high antecedent soil moisture conditions, which combined with a large rain event beginning on January 24, 2010, produced 12 overflows. (See Figure 4) There was another significant rain on November 29, 2010, where the area received 3.5 inches of rain within a five-day period and 11 inches in the 60 days prior that resulted in nine wet-weather related overflows at the end of the year. These two rain events accounted for 64 percent of the wet-weather events in 2010. Improvements already made in the collection system have dramatically decreased the effects from rainfall patterns and antecedent soil moisture conditions.

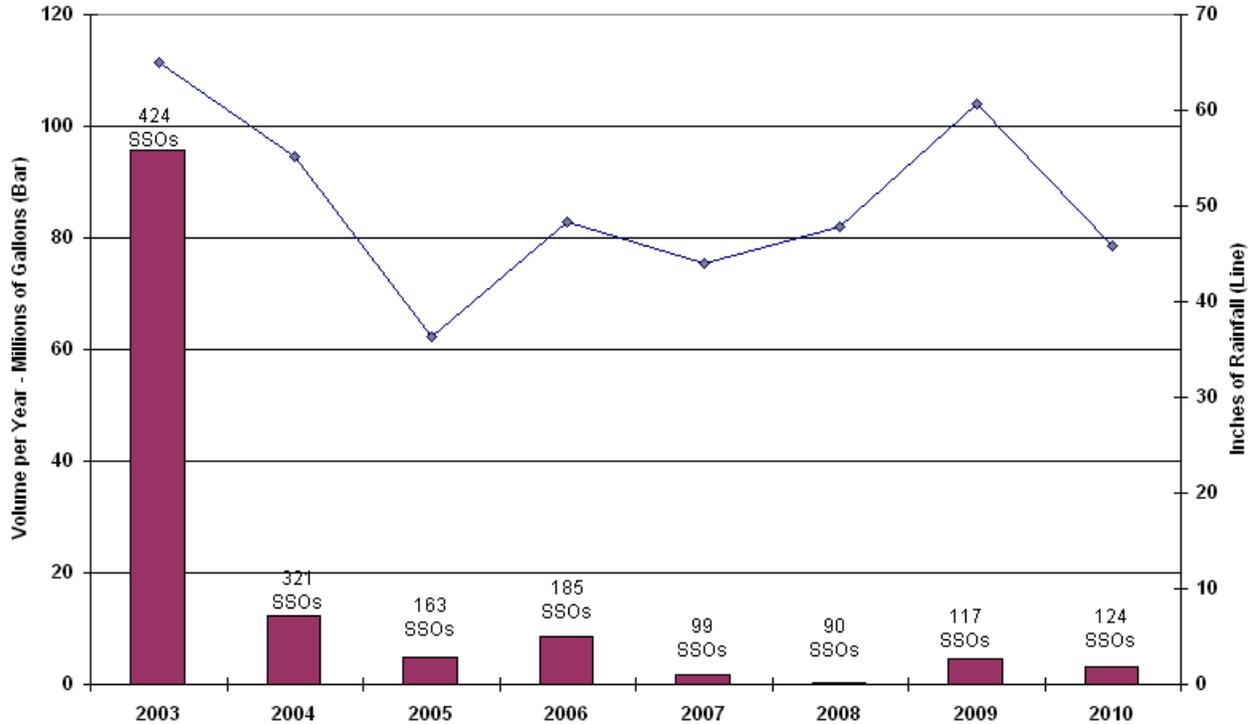
Figure 5.A

**Total SSO Volume per Year
(Including Building Backups)**

Figures 5.A and 5.B represent the SSO volumes between 2003 and 2010. For Figure 5.B, the SSO volumes were grouped into four volume ranges:

Total volumes have decreased significantly since 2003, by over 95 percent. The dramatic decrease in total overflow volumes from 2006 to 2007 is attributed to very low rainfall totals. All of the overflows that occurred in 2007 were dry-weather events. This downward trend continued in 2008 with the use of four storage tanks to help manage peak wet-weather flows. The increase in 2009 and 2010 was a result of increased rainfall, although the total for 2010 was 30 percent lower than the previous year. It is important to note that KUB attempts to recover as much volume as possible during each event and respond to overflows as quickly as possible, which results in lower discharge volumes. Also, the use of KUB's four new storage facilities and ongoing rehabilitation efforts have significantly reduced the flows in the sewer system during heavy rainfall events thereby minimizing the amount of unrecovered volume.

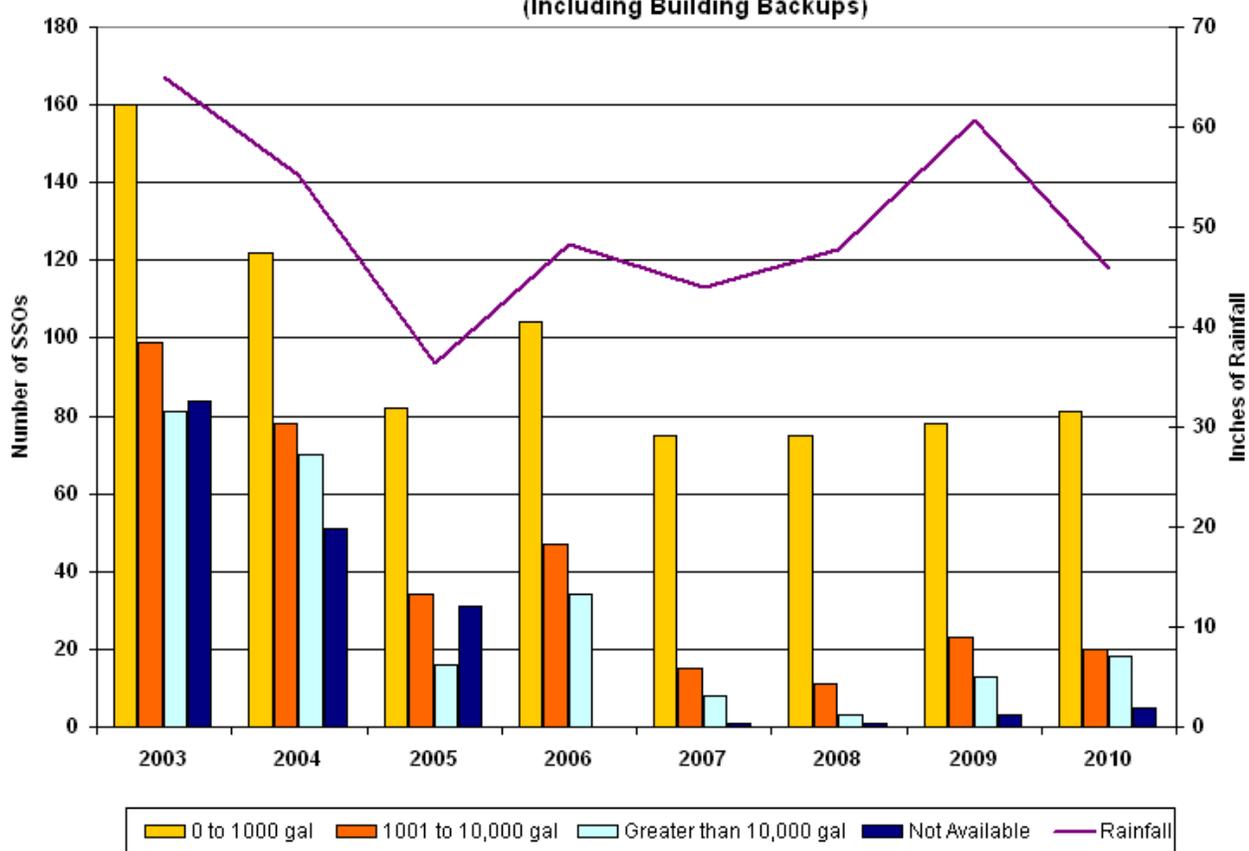
Figure 5.B
Sanitary Sewer Overflow Volumes
(Including Building Backups)

This volume range represents the volume estimations that responders were either not able to calculate or were not required to calculate according to KUB's record-keeping practices. KUB has not recorded the volume related to building backups. Under KUB's revised SORP, crews calculate volumes for both overflows and building backups, where sufficient data is available. There were five cases in 2010 where the total could not be estimated because the overflow had occurred at some point in the past and was not detected until the overflow had stopped. Situations where the overflow is discovered at a later date do not always allow a volume estimate to be calculated.

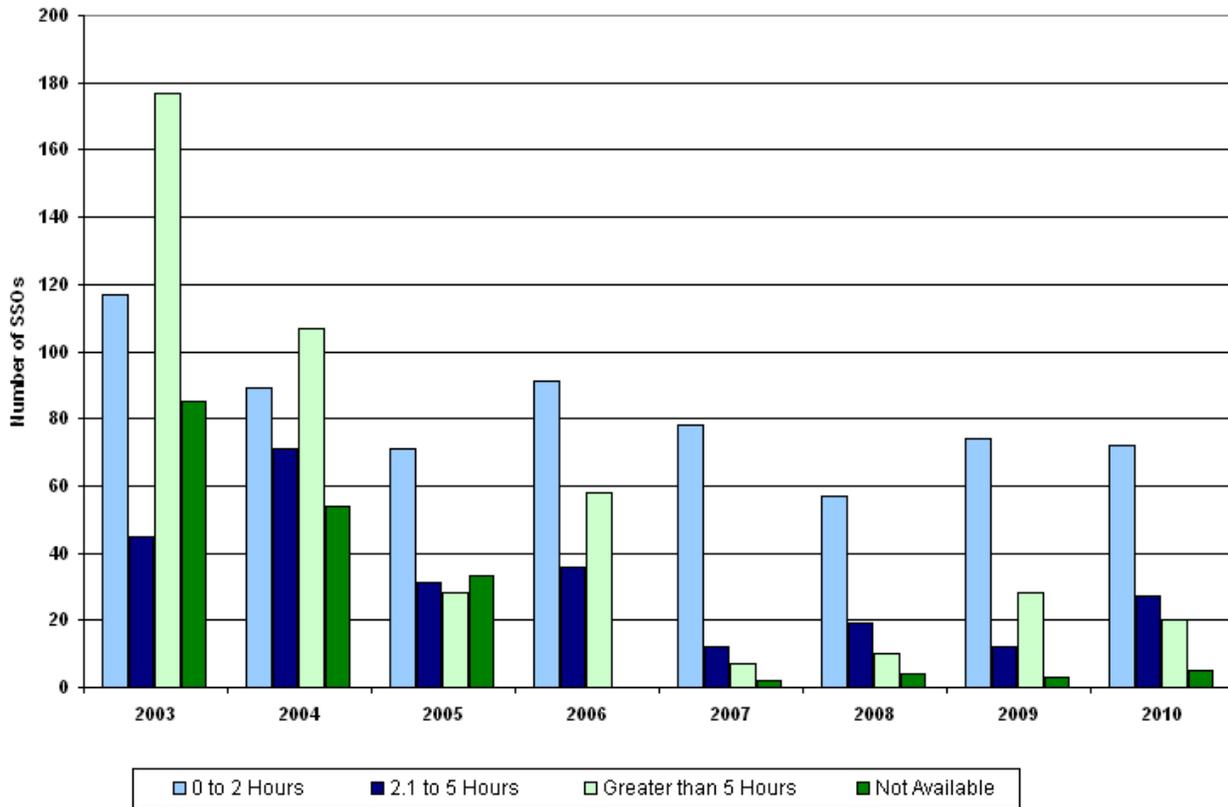
Figure 6
Sanitary Sewer Overflow Durations
(Including Building Backups)

Figure 6 represents the SSO durations between 2003 and 2010. Durations are typically based on the amount of time elapsed since the overflow was first observed until the time the overflow was observed to have stopped. In cases where KUB can document or has reason to believe the overflow had been ongoing prior to observation, durations may be estimated. In many cases, KUB mitigated the overflow shortly after confirmation of the event. The SSO durations were grouped into four ranges:
